Manhole Inspection Summary

Manhole # S69S__021MH

Insp Date: **5/27/08 9:12 AM**

Location Address: **1701 Malvern St.**

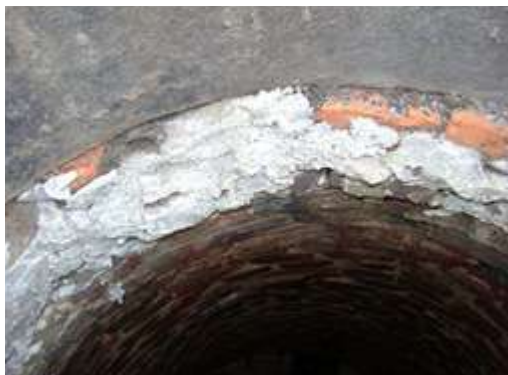
Defect 1

Condition: ☐ Sound ☐ Cracked ☐ Root Intrusion ☒ **Loose Brick** ☒ **Deteriorated**

cracking mortar

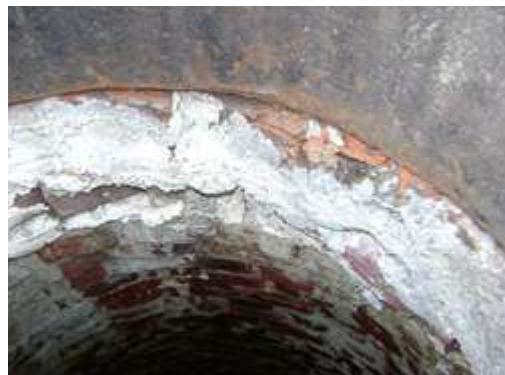
Defect 3

cracking mortar

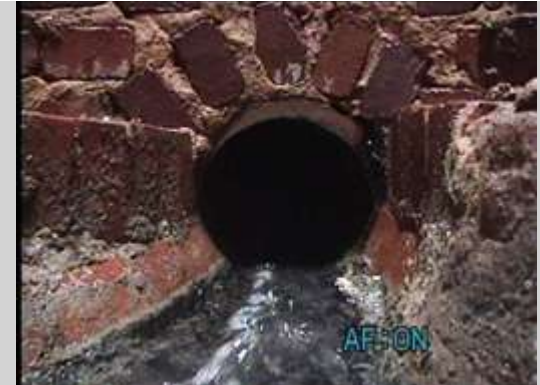
12 O'Clock Outflow

8 in. Circular Gravity Sewer
Pipe Out @ 12 O'Clock

Pipe Height: **8.4** (in.) Rod and Bar (Angled)
Pipe Material: **Clay** ☐ Pipe Lined
Invert Depth: **9.58** (ft.) Flow Characteristics: **Fast**
Deposits: ☒ None ☐ Mud ☐ Sludge ☐ Debris ☐ Grease
Silt Depth: (in.) Deposits Extent:
Infiltration: **None** Pipe Seal Cond: **Sound**

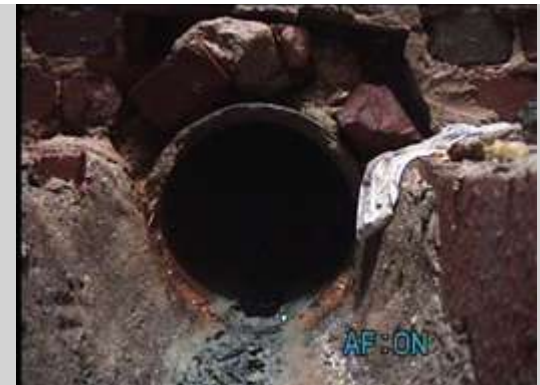
3 O'Clock Inflow

8 in. Circular Gravity Sewer
Pipe In @ 3 O'Clock

Pipe Height: **8.4** (in.) Rod and Bar (Angled)
Pipe Material: **Clay** ☐ Pipe Lined
Invert Depth: **8.92** (ft.) Flow Characteristics: **Slow**
Deposits: ☒ None ☐ Mud ☐ Sludge ☐ Debris ☐ Grease
Silt Depth: (in.) Deposits Extent:
Infiltration: **None** Pipe Seal Cond: **Broken**

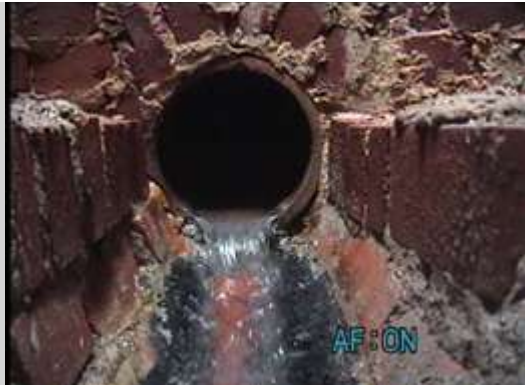
6 O'Clock Inflow

Pipe In @ 6 O'Clock

Infiltration: **None** Pipe Seal Cond: **Sound**

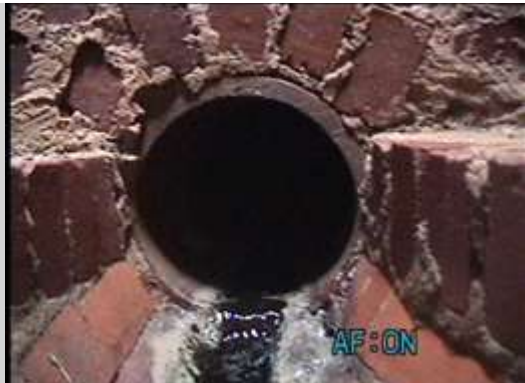
9 O'Clock Inflow

Pipe In @ 9 O'Clock

Infiltration: **None** Pipe Seal Cond: **Sound**
